Columbia Crew Survival Investigation Report

NASA/SP-2008-565

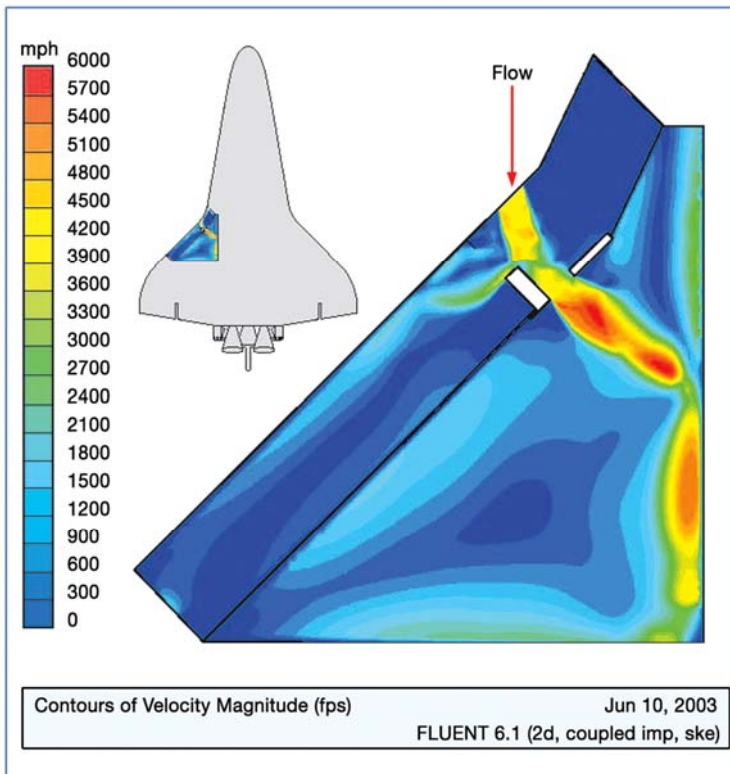
The CAIB concluded that the breach in the TPS on the leading edge of the left wing allowed hot gas to penetrate the wing and to work its way aft and inboard, toward the midbody fuselage and left main landing gear wheel well (figure 1.1-9). CAIB analysis showed that this eventually caused significant internal damage to *Columbia*'s left wing, changing the wing's aerodynamic properties. There were no indications to the crew of this ongoing damage. Throughout phase 2, the orbiter Flight Control System (FCS) corrected for the damage-induced yaw and roll moments, and control of the orbiter was maintained.⁸

Figure 1.1-9. The effects of wing Thermal Protection System damage as reported by the Columbia Accident Investigation Board.

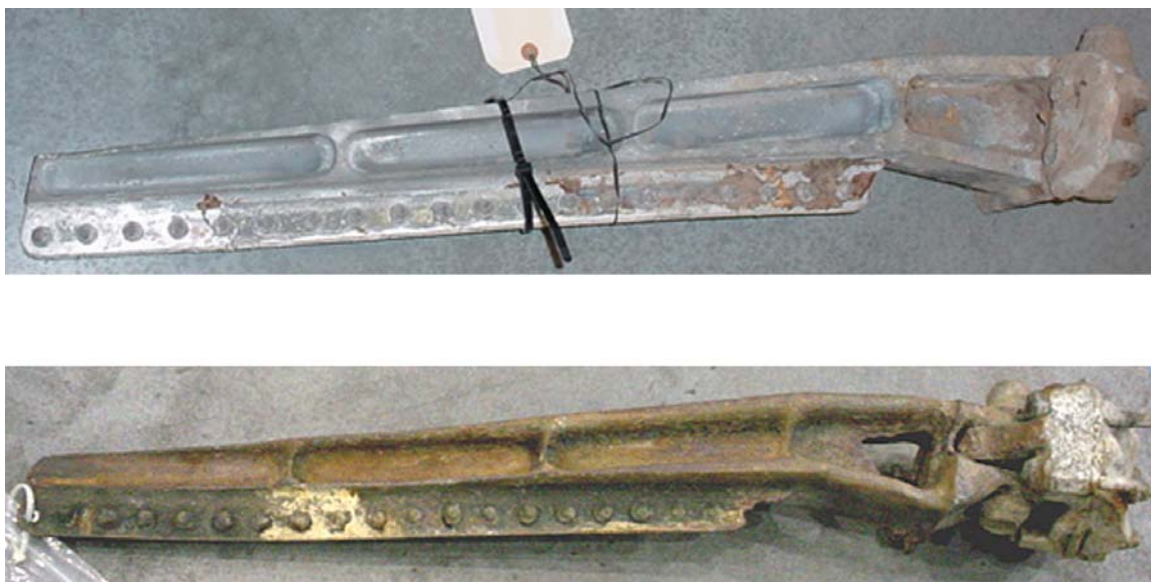
sill, and was likely from a combination of thermal degradation and structural loads. The forebody probably separated from the midbody from starboard to port. Based on structural evidence and the debris field, the crew module remained with the forward fuselage indicating that the links attaching the two structures remained intact. The remaining orbiter structure separated into aft and midbody/right wing segments. See Chapter 2. Figure 1.1-25 shows the recovered x-links.

Figure 1.1-25. Port x-link, debris item no. 1678 (top), and starboard x-link, debris item no. 1765 (bottom), from the Columbia Reconstruction Database.

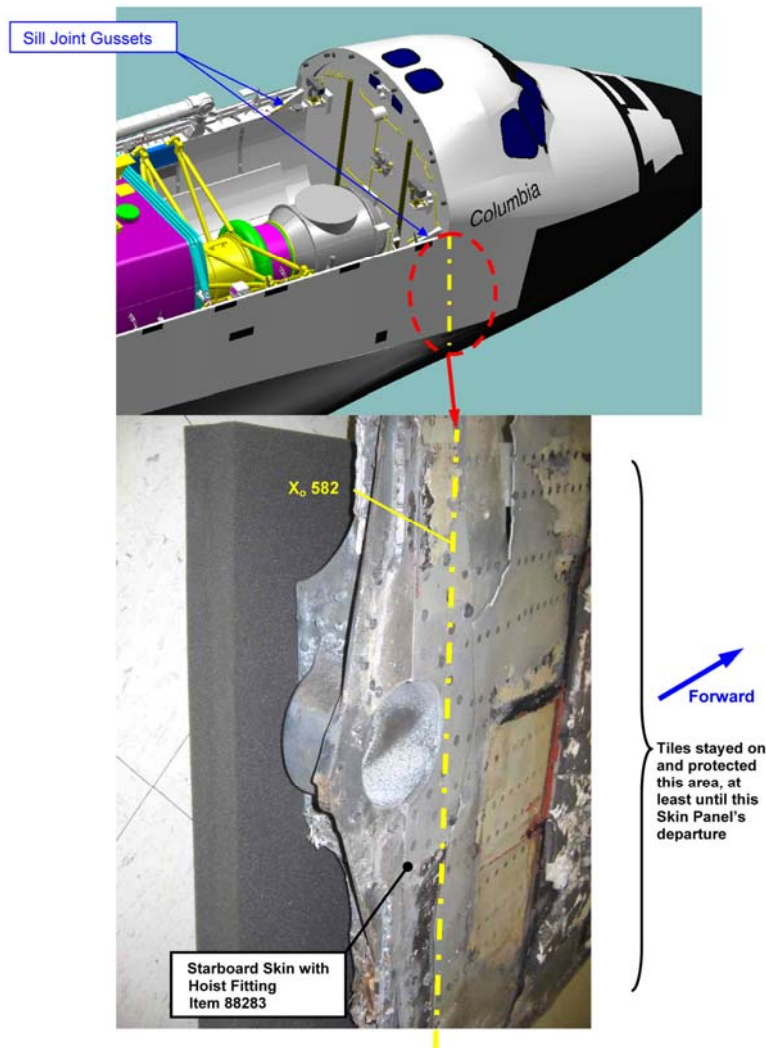
Figure 2.2-32. Forward fuselage skin still attached to the starboard hoist fitting.

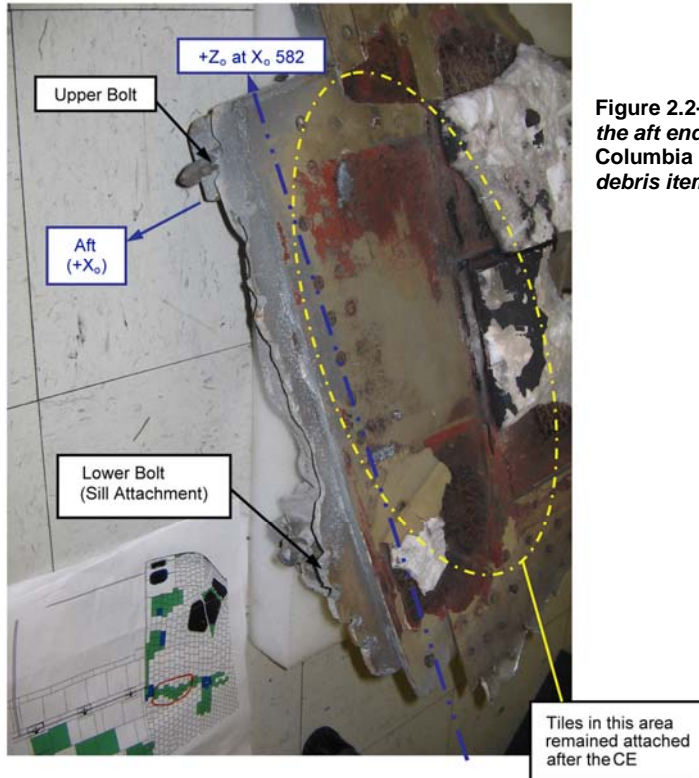
Figure 2.2-33. Thermal erosion on the aft end of the starboard-side skin, Columbia Reconstruction Database debris item no. 2436.

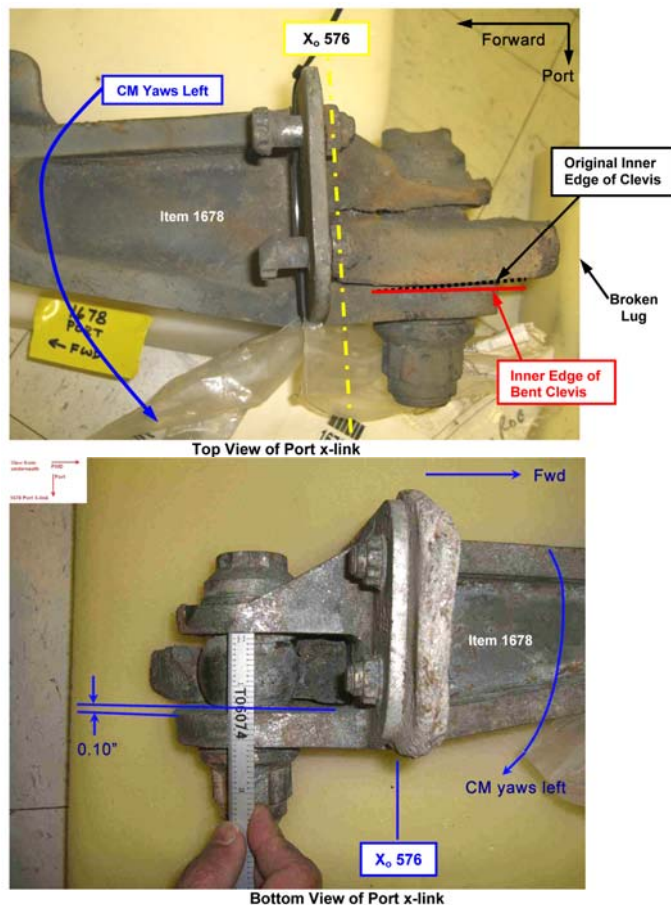
Figure 2.2-46. Views of the port x-link with about a 0.10-inch yield on the outboard side of the clevis.

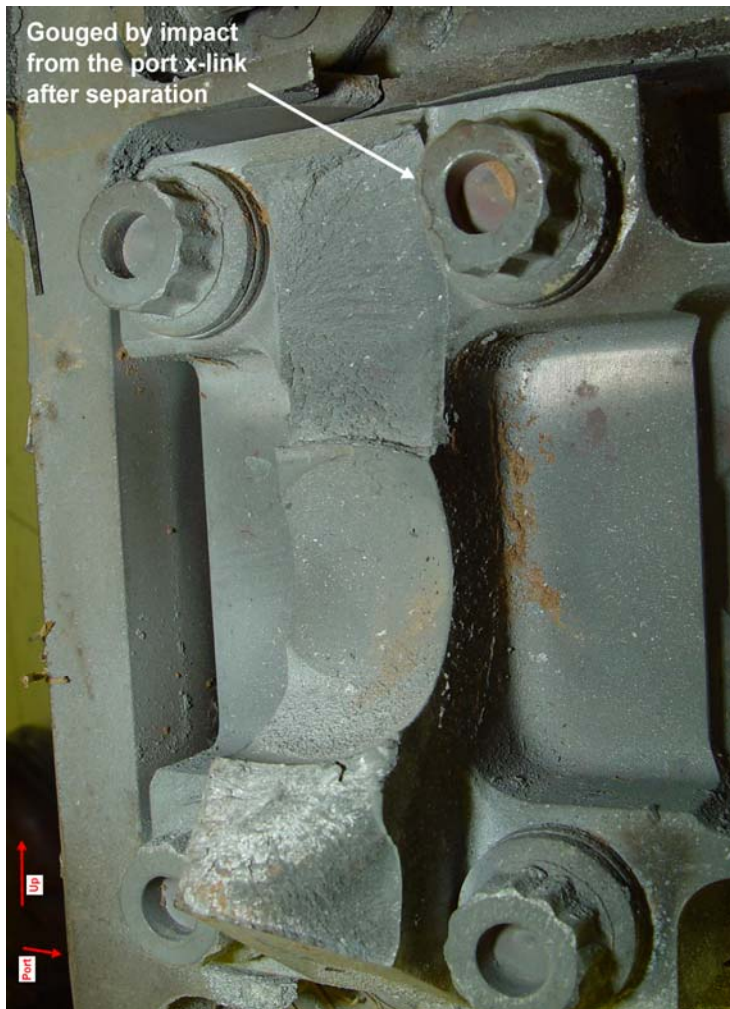
Figure 2.2-47. Columbia Reconstruction Database debris item no. 2207, which includes the remainder of the lug fitting that supports the aft end of the port x-link.

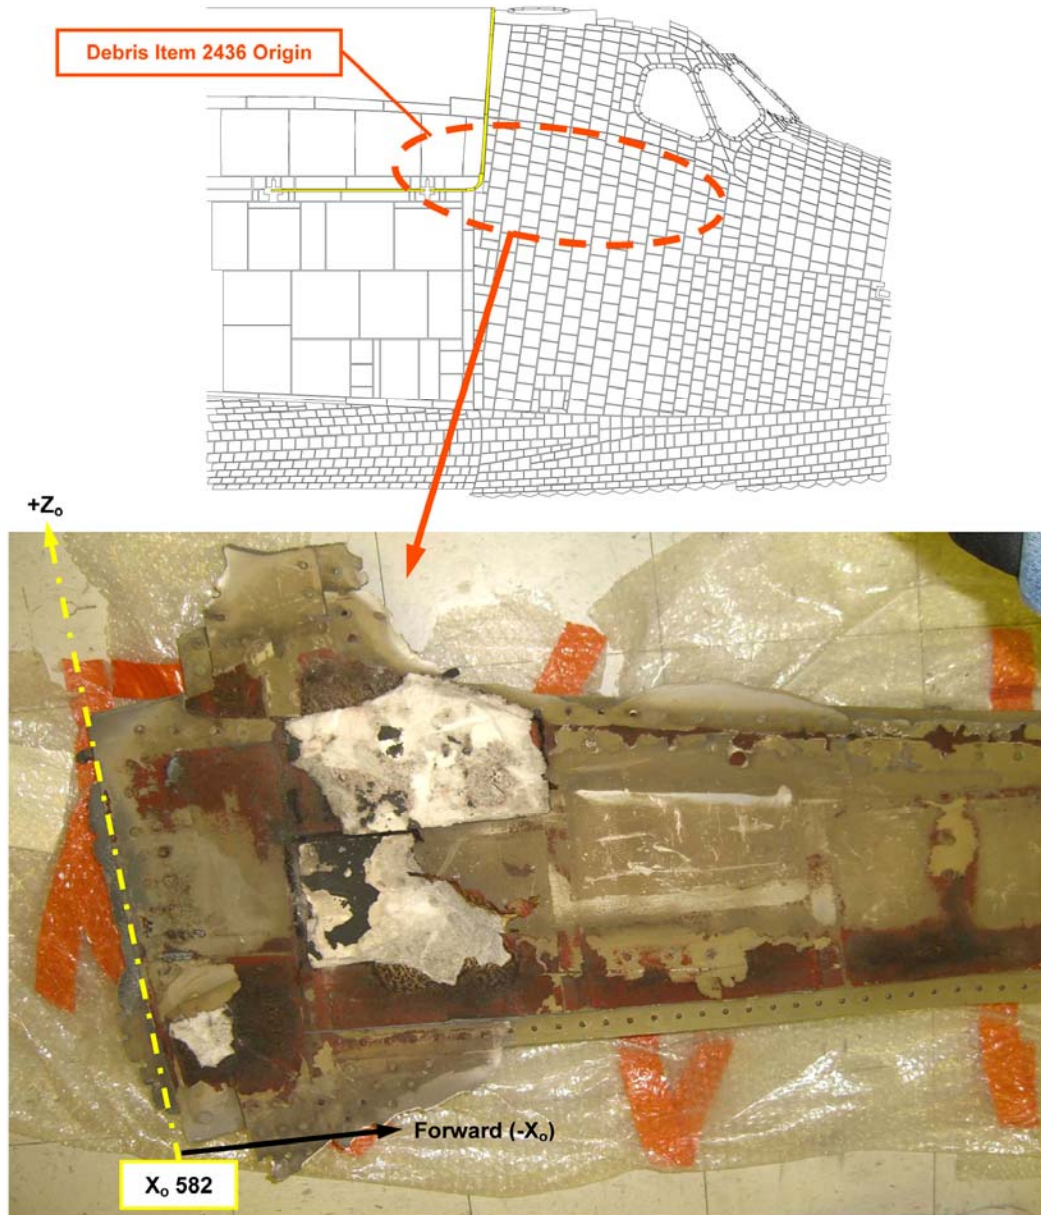
Figure 2.4-26. Starboard-side skin, view looking inboard, Columbia Reconstruction Database debris item no. 2436.

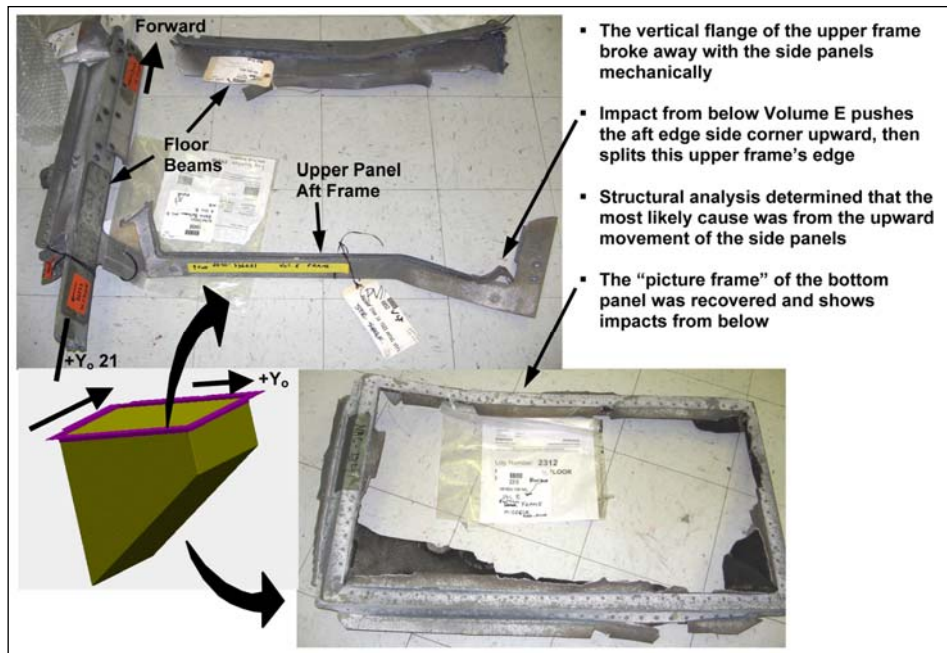
Figure 2.4-32. Volume E debris damage.

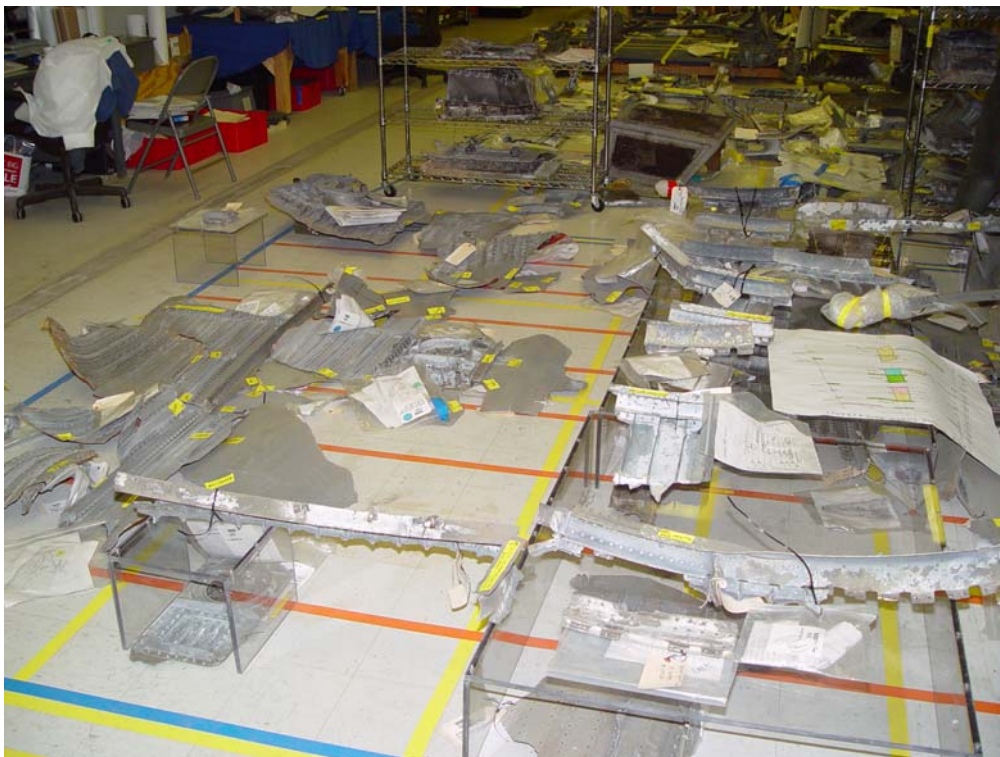
Figure 2.4-40. Lower forward fuselage skin and frame debris.

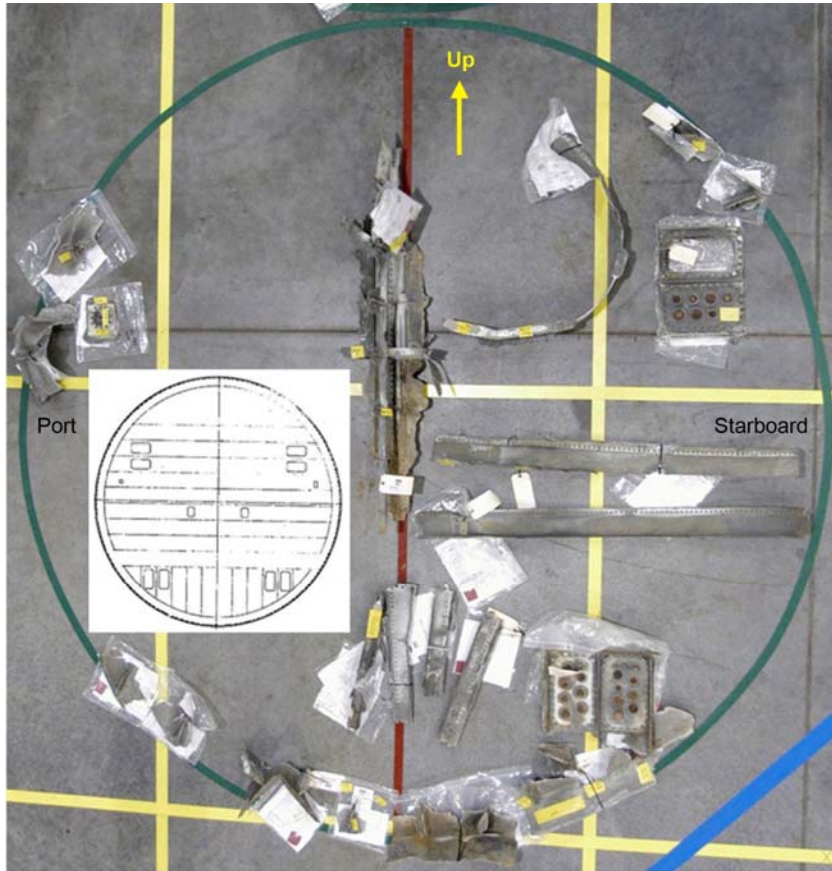
Figure 2.4-42. View looking forward of the recovered crew module X_{cm} 200 bulkhead debris.

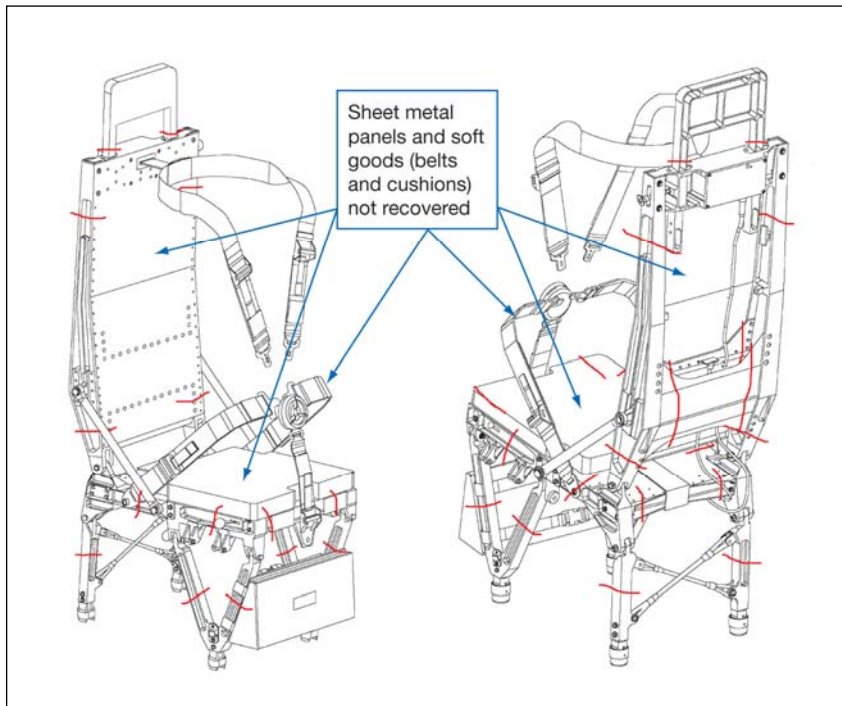
Figure 3.1-12. Common seat failure locations (shown in red). [Adapted from the Space Shuttle Systems Handbook]

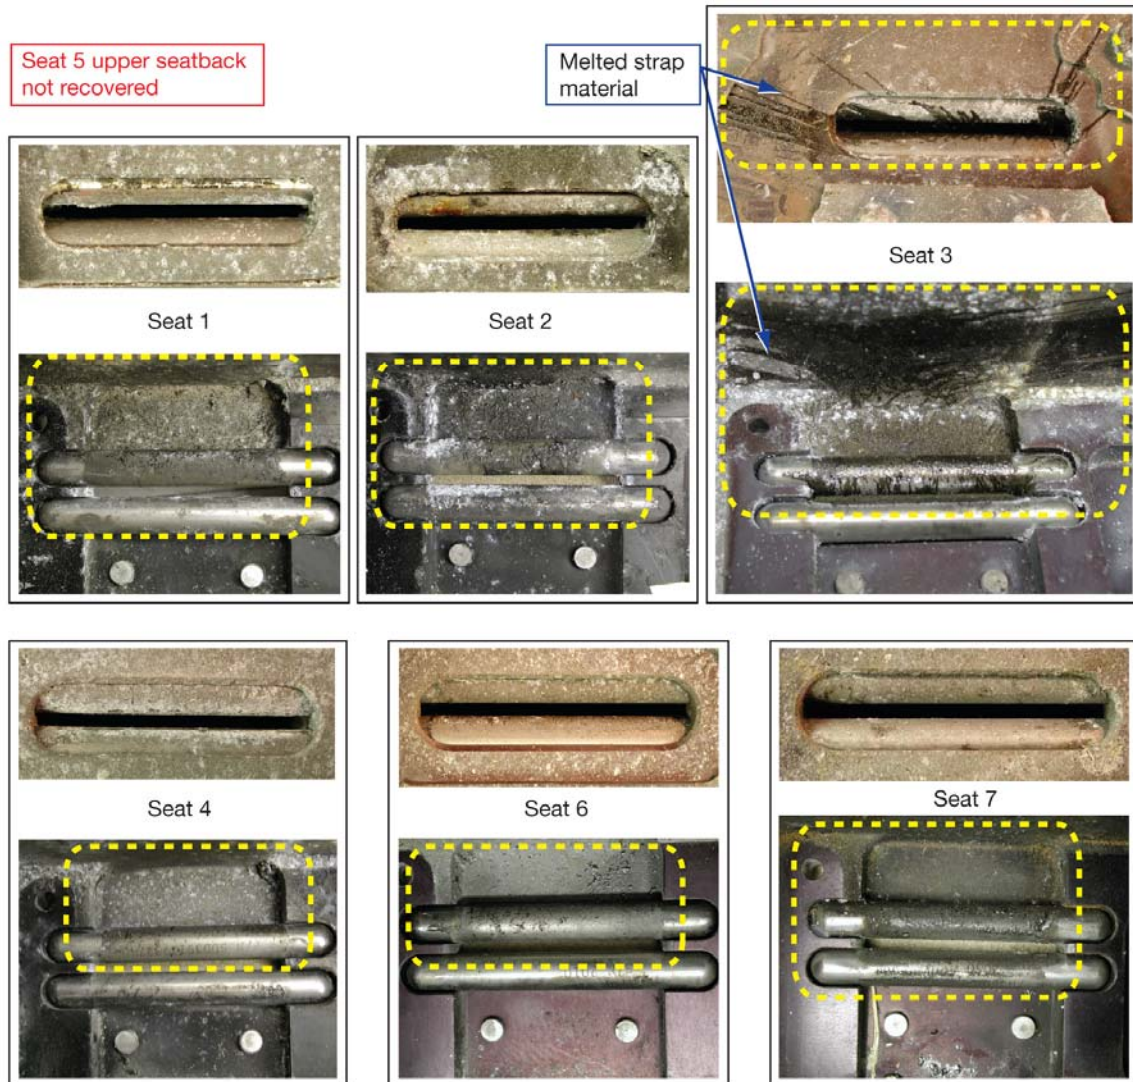
Figure 3.1-22. Upper seatback inertial reel strap pass-through slots – external (top)/internal (bottom); melted strap material areas outlined in yellow.

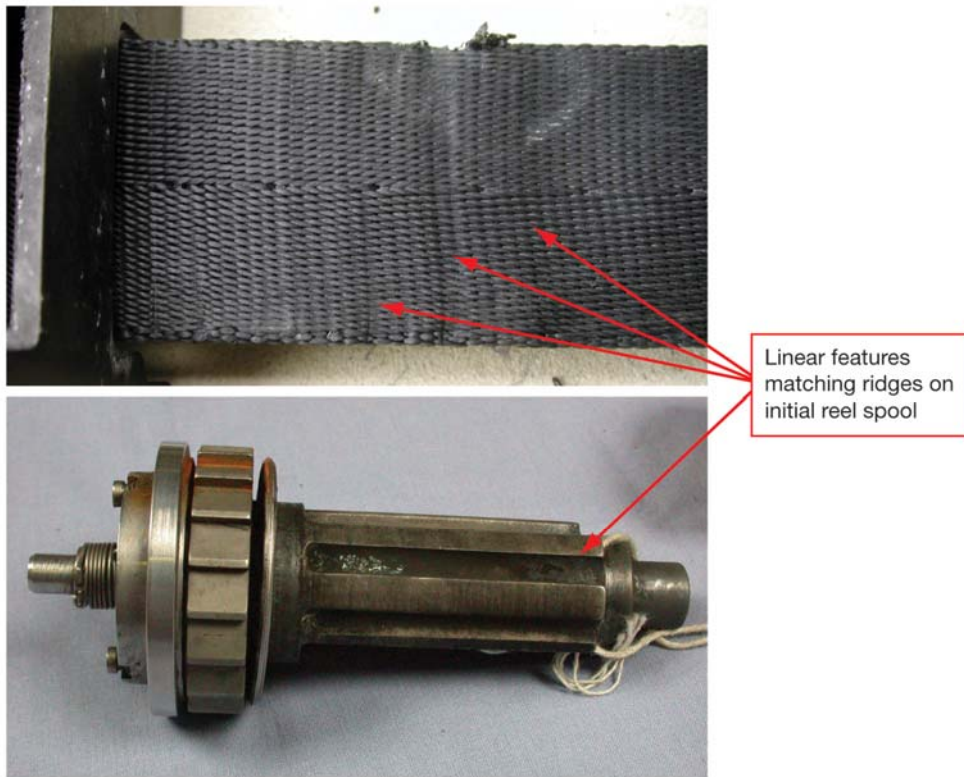
Figure 3.1-25. Example of linear waves on inertial reel straps.

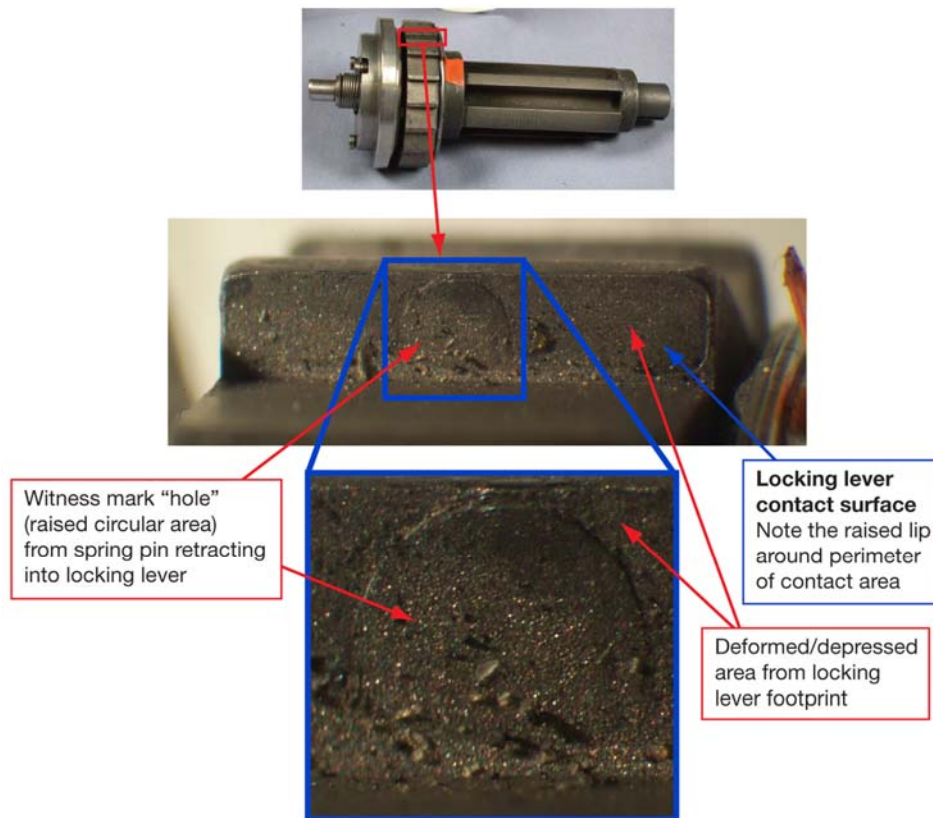
Figure 3.1-33. Inertial reel locking gear witness mark.
